After scanning the entire flat roof system for defects I located multiple punctures and wet spots, 11 in total. The marked square footage of those 11 spots comes to 801SF. Section E or "marquee roof" has had multiple spots of deck failure due to long term leakage around flashing and windows. I would estimate over 50% of the insulation on Section E is wet, damaged or missing and would not recommend restoring this section.

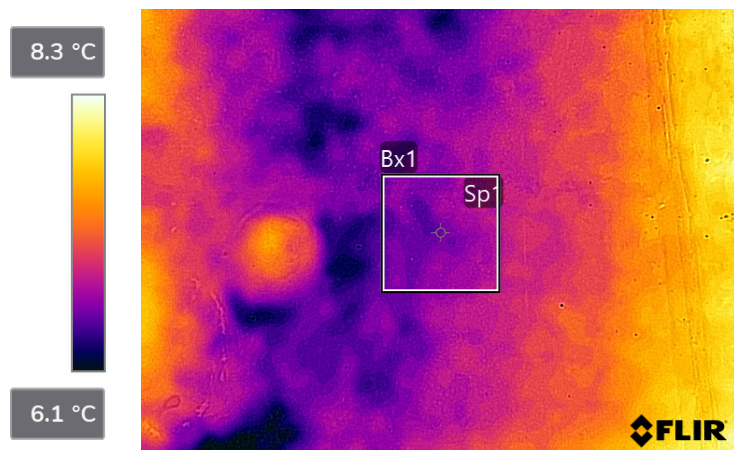
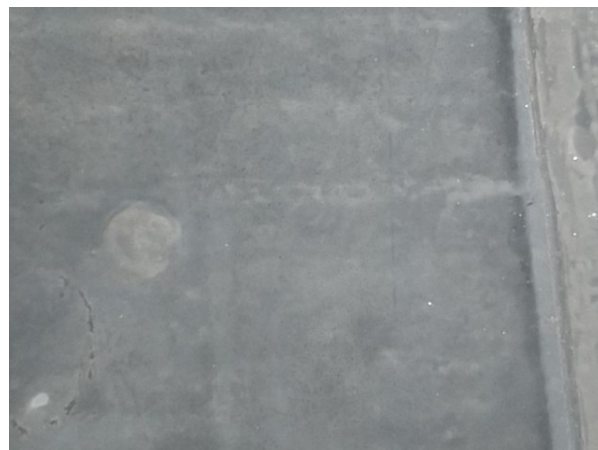
flir\_20211119T160335.jpg

This is a test shot to check settings on camera and get a base temprature reading on a known dry area of roofing.

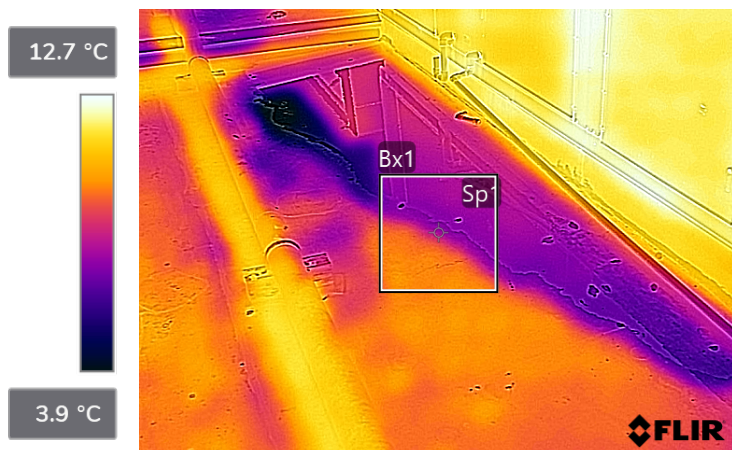
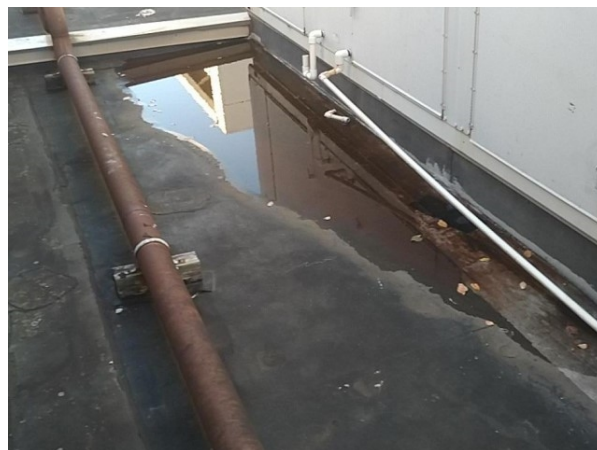
flir\_20211119T160836.jpg

This area of the roof system ponds water and should be addressed with a cricket. Issues have been repaired here in the past, however the IR reflects off the pool making it impossible to get a picture of the wet insulation substrate.

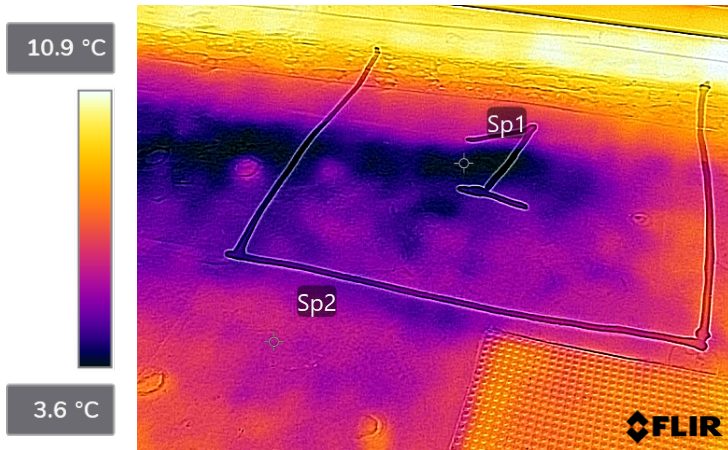
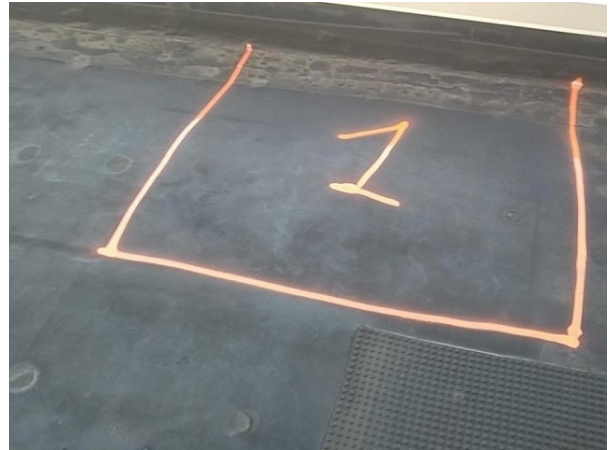
flir\_20211119T160449.jpg

**Spot 1 | located leak caused by puncture and wet insulation approx. 4' by 4'**

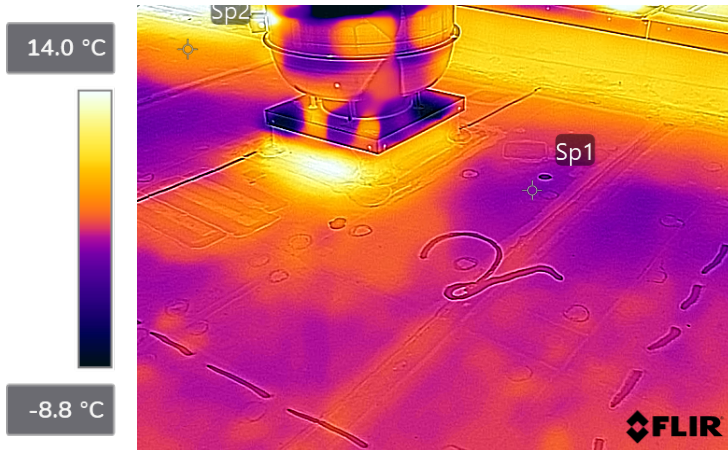
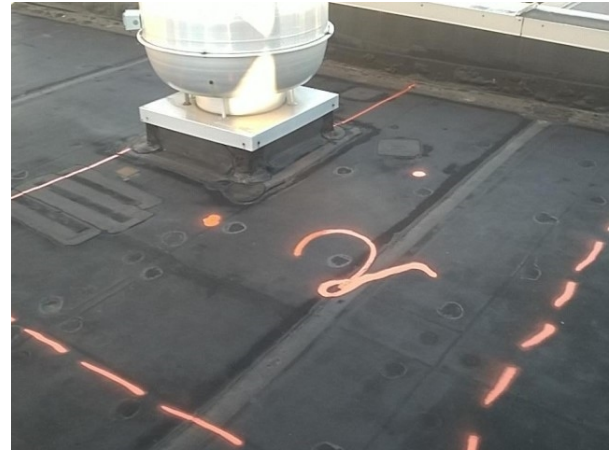
flir\_20211119T160638.jpg

Spot 2 | located puncture in membrane and wet insulation around RTU with an approx. size of 10' by 8'

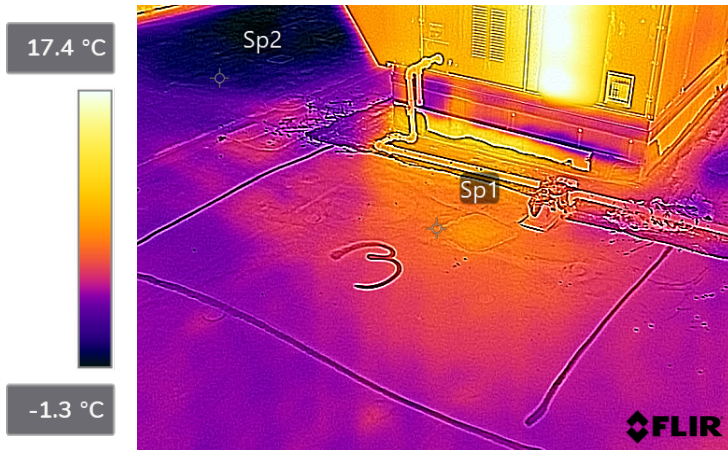
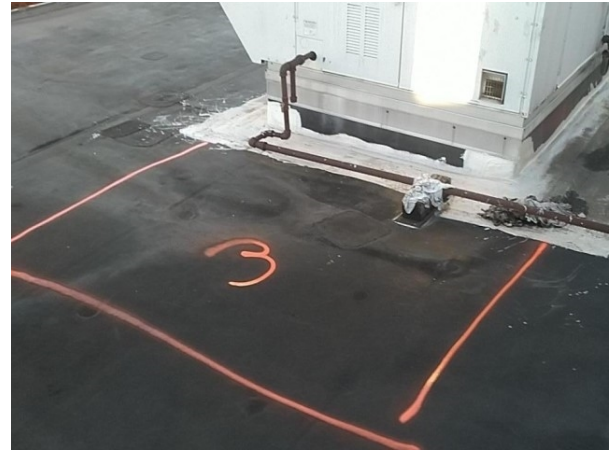
flir\_20211119T160756.jpg

Spot 3 I located an area of insulation that has been wet before and has degraded to a point that it has visible humps. The size is 5' by 5'

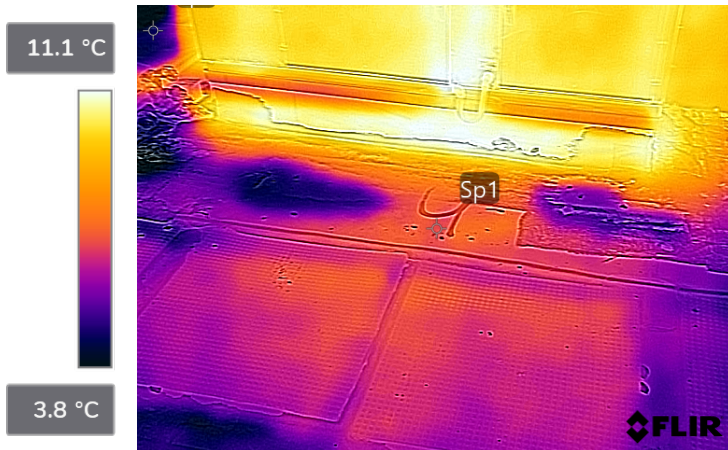
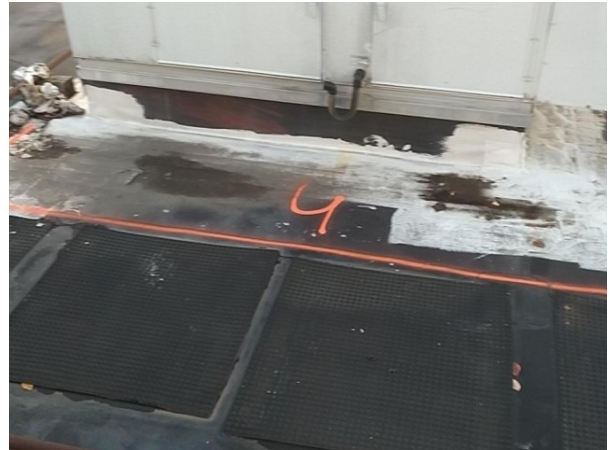
flir\_20211119T160905.jpg

Spot 4 I found water in the flashings and damp insulation on the top side of an RTU curb 3' by 9' in size.

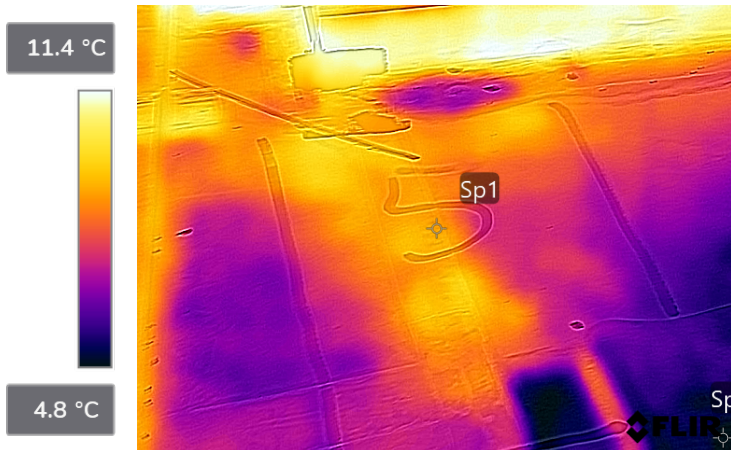
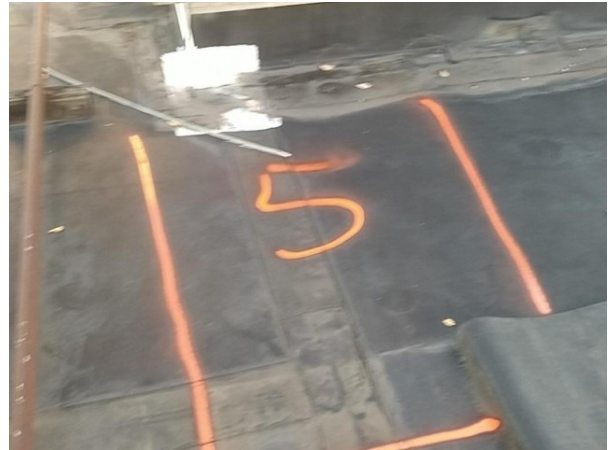
flir\_20211119T161032.jpg

Spot 5 I found a puncture in the membrane and wet insulation approx. 3' by 4'.

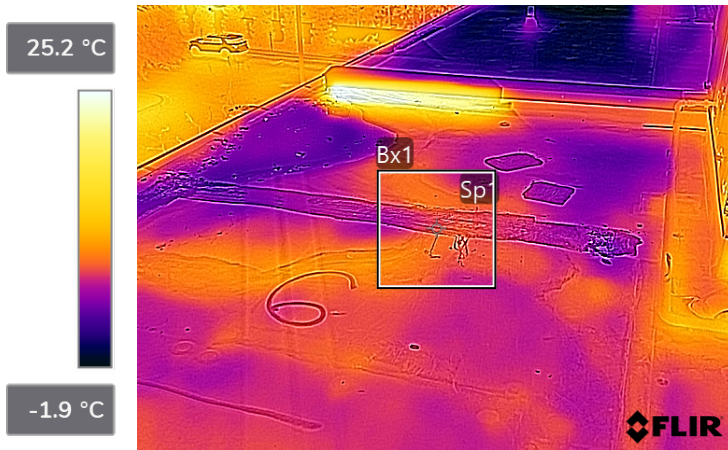
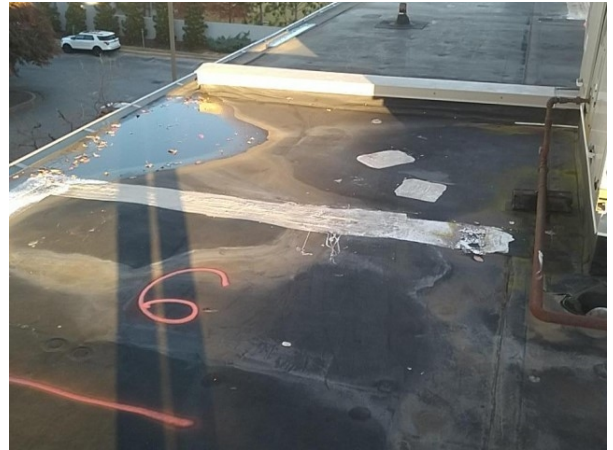
flir\_20211119T161124.jpg

Spot 6 I located a large section of wet insulation extending from and RTU to the expansion joint and the drip edge. Size 12' by 12'

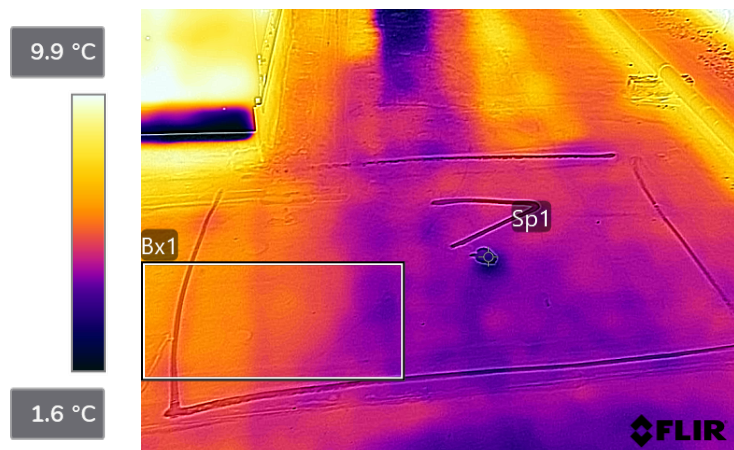
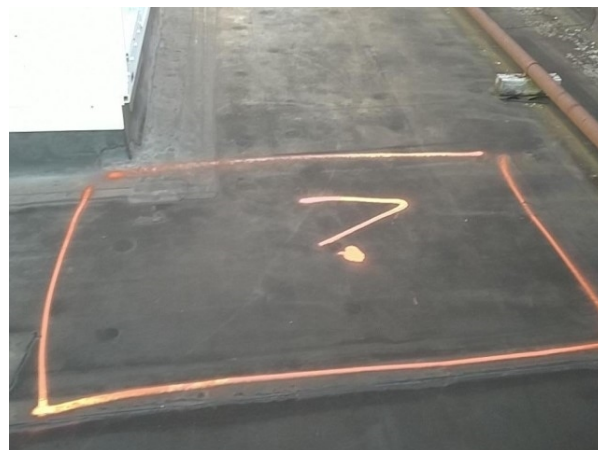
flir\_20211119T161151.jpg

Spot 7 I located a puncture in the membrane and wet insulation about 6' by 4'.

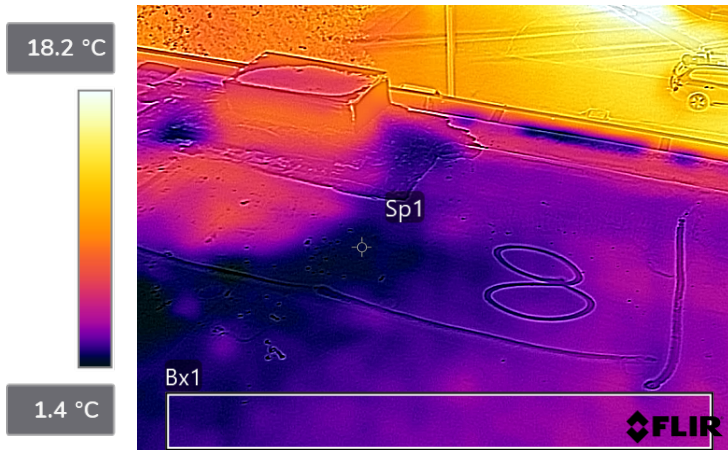
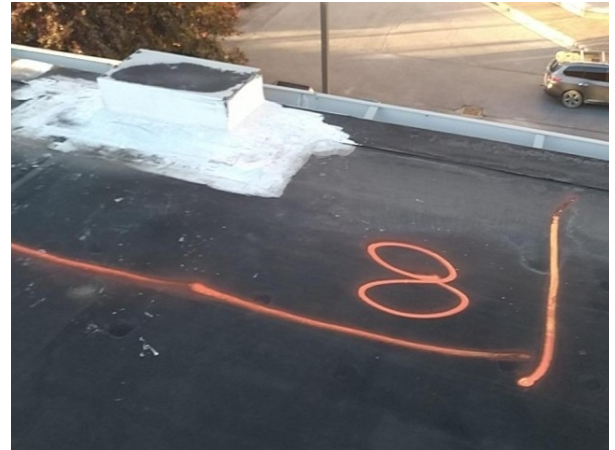
flir\_20211119T161454.jpg

Spot 8 I found moisture in flashings and moisture in insulation all along the drip edge about 4' by 35'.

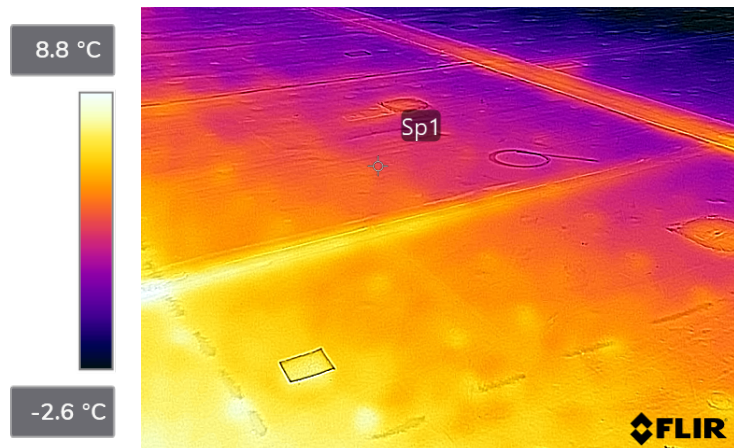
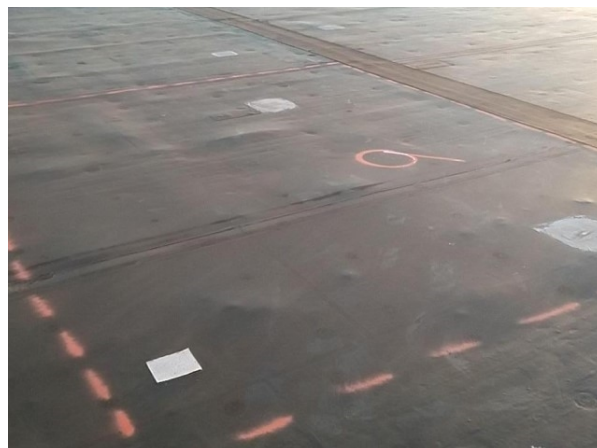
flir\_20211119T164029.jpg

Spot 9 I found insulation that has been wet and some spots where it is buckling up due to moisture damage, approx. 10' by 15'.

Spot 10 I found insulation that has been wet and damaged approx. 10' by 10'. Spot 9 and 10 had heat radiated from wall affecting the shot, when viewed from several angles you can draw an outline.

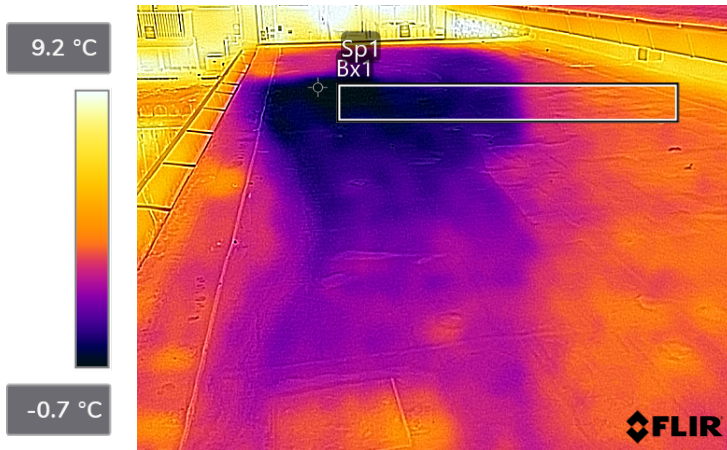
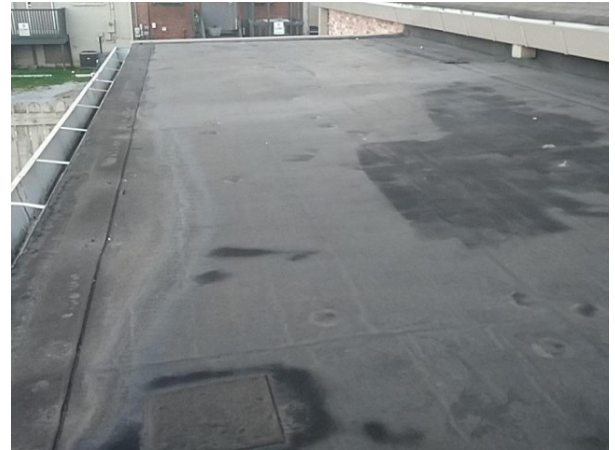
flir\_20211119T164950.jpg

**Spot 11 I found a puncture in the membrane and a large area of wet insulation extending out from the corner of the building about 14' by 7'.**
