Roof Asset Management Program

Princess Theatre Roof Report

March 08, 2021

Client: City of Decatur

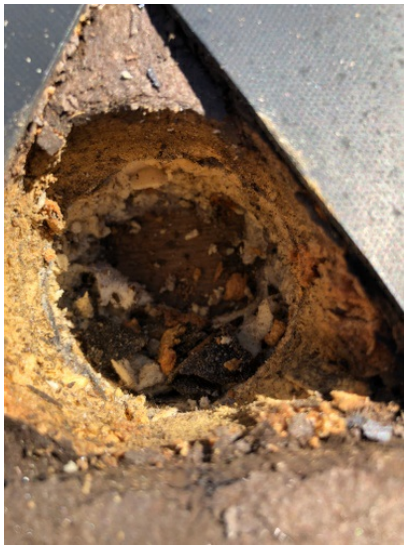
Photo 1

Roof Core Data: EPDM Roof, 2" ISO, Wood Deck

Slope is in Deck

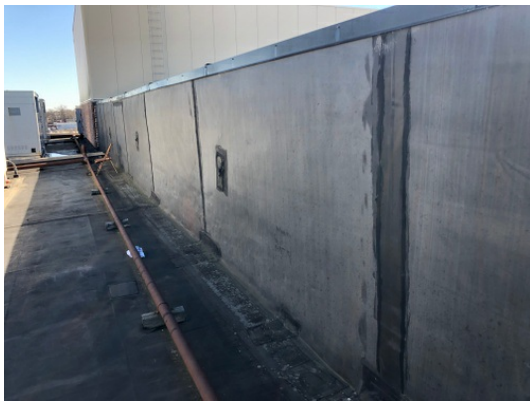
Photo 4

Walls are approximately 6' tall

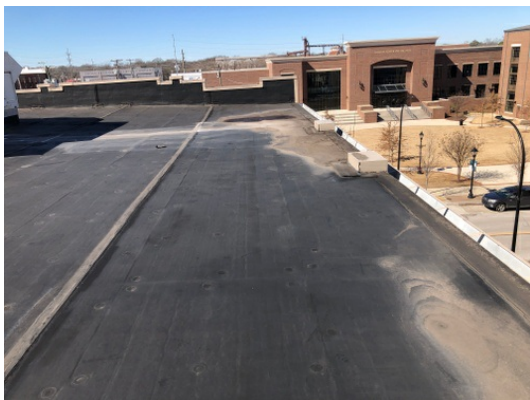
Photo 5

Water ponds down at the low end of the roof in front of the gutters.

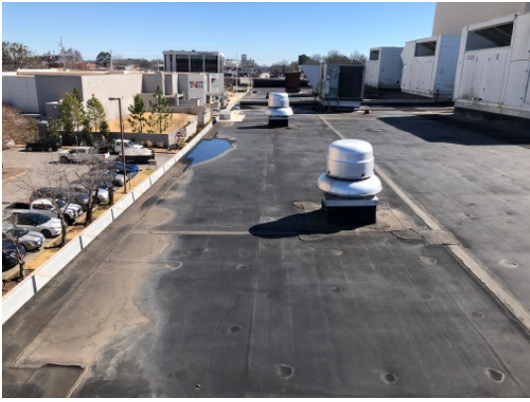
Photo 6

Water ponds down at the low end of the roof in front of the gutters.

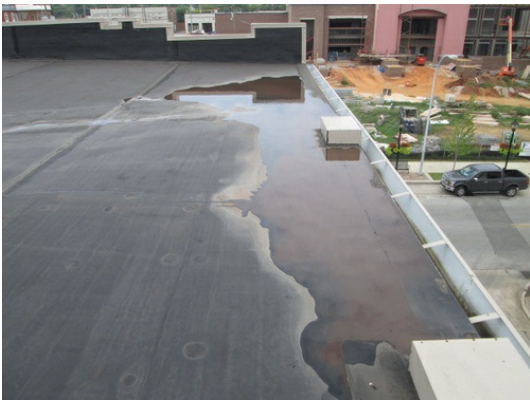
Photo 7

Water ponds down at the low end of the roof in front of the gutters.

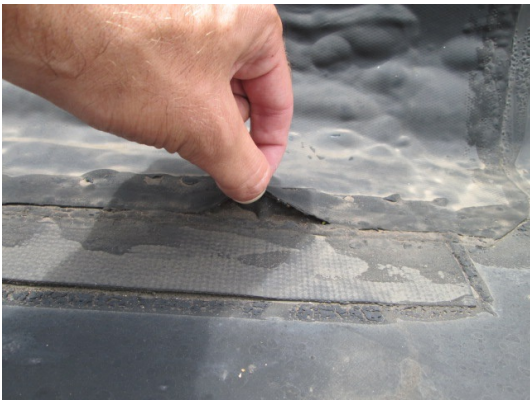
Photo 8

The roof is old and needs to be replaced.

1. Tear off existing EPDM membrane and dispose of properly. Core sample showed that the EPDM membrane was not adhered to the ISO very well and peeled right off.

2. Include 1000 SF of wet insulation to be torn off and replaced in base bid. (2" Iso needed for fill)
3. Mechanically fasten a ½" HDWF through the existing ISO into the wood deck.

4. Install 1 layer of FlexBase 80 in Weatherking membrane adhesive at 2.5 gallons per square.
5. Install StressPly Mineral cap sheet in Weatherking membrane adhesive at 2.5 gallons per square.

6. Heat weld all seams.
7. Install two ply flashings to all projections and at the perimeter; the first being FlexBase 80 and the second StressPly Mineral, in Flashing Bond. Flashing height must not exceed 24". Use two-piece flashing detail where parapet wall exceeds height limitation.

8. Install a 3-course application of SilverFlash and Gar-Mesh 6" to all vertical flashing laps.
9. Install new sheet metal details at all projections and perimeter according to Garland details, specifications and best roofing practices.

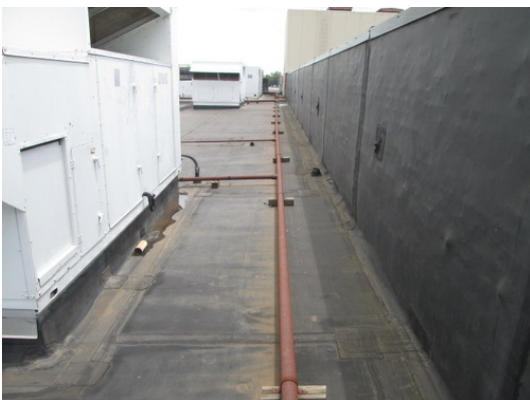
Photo 9

There are several large mechanical units on the roof.

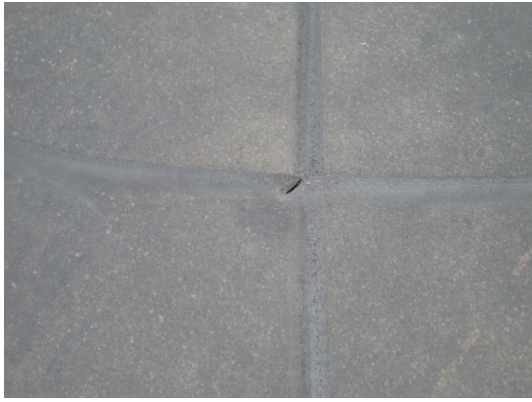
Photo 10

Small punctures like this have been repaired every year for the last several years.

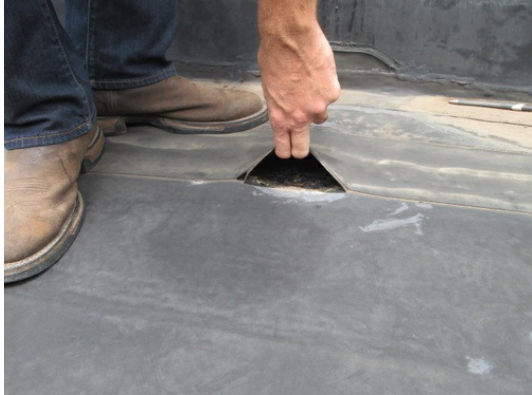
Photo 11

Large fish mouth that is likely a roof leak.

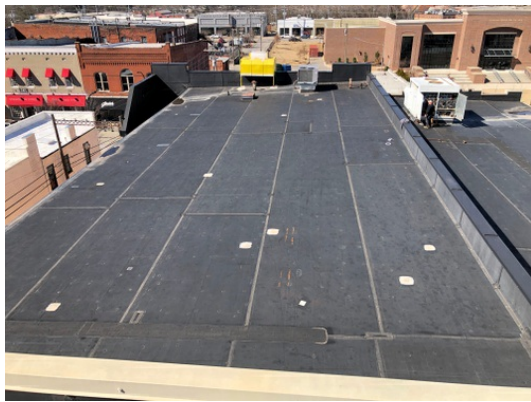
Photo 2

All the white areas are previous roof leaks with repairs.

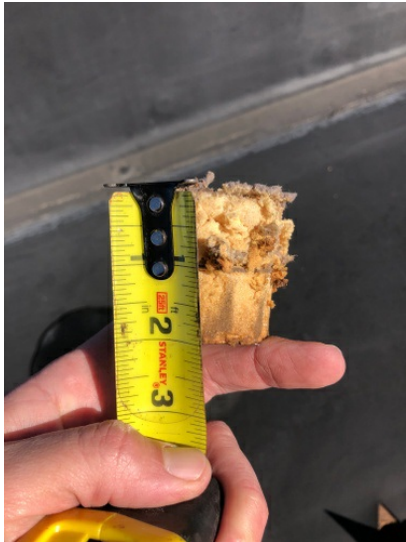
Photo 4

Roof Core Data: EPDM Roof, 2" ISO, Wood Deck

Slope is in Deck

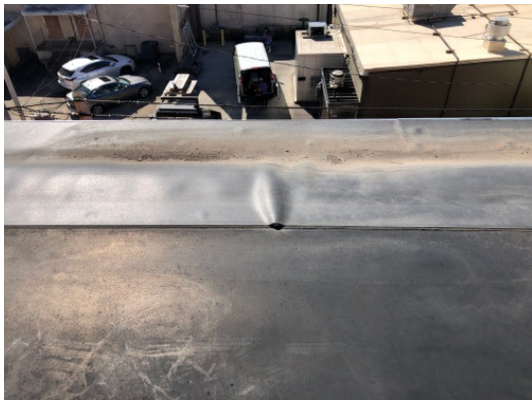
Photo 7

The flashing on the drip edge has a few fishmouths.

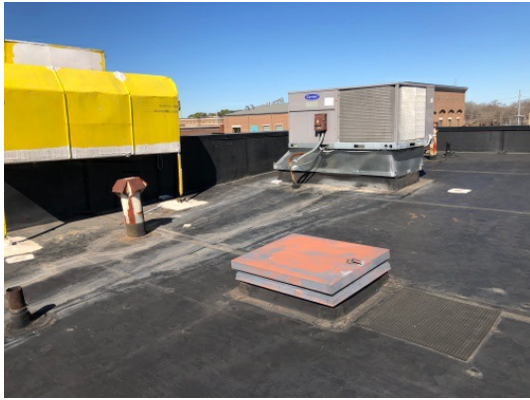
Photo 11

There is one mechanical unit on the roof and several other penetrations.

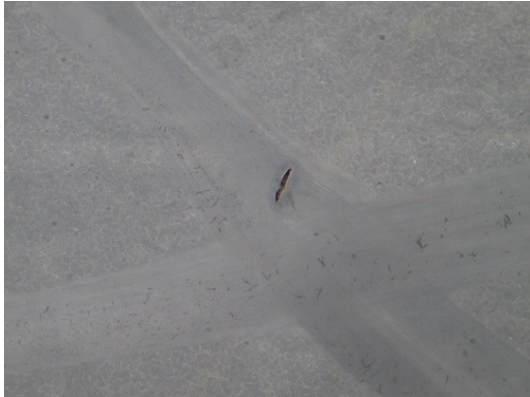
Photo 12

Small tears like this have been common.

1. Tear off existing EPDM membrane and dispose of properly. Core sample showed that the EPDM membrane was not adhered to the ISO very well and peeled right off.

2. Include 1000 SF of wet insulation to be torn off and replaced in base bid. (2" Iso needed for fill)
3. Mechanically fasten a ½" HDWF through the existing ISO into the wood deck.

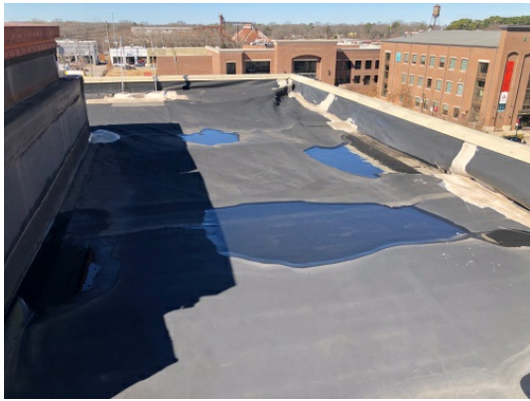
Photo 1

** Section C is at risk of blowing off **

Immediate attention required

The worst area of the roof that is failing.

1. Tear off existing roof down to the deck.
2. Nail a base sheet to the deck.
3. Adhere 1/4" tapered insulation.
4. Adhere 1/2" coverboard.
5. Adhere new roof system.

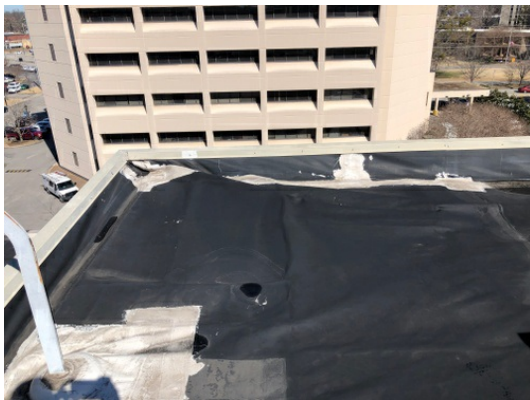
Photo 2

The worst area of the roof that is failing.

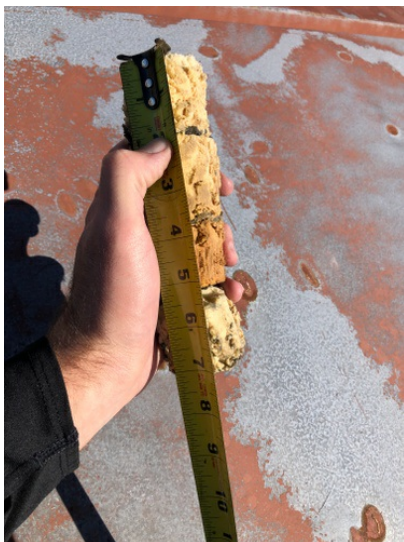
Photo 3

Roof Core Data: EPDM Roof, 1/4" tapered ISO, Lightweight Concrete or Gyp Deck

Slope is in the insulation (2" on low side and 10" on high side)

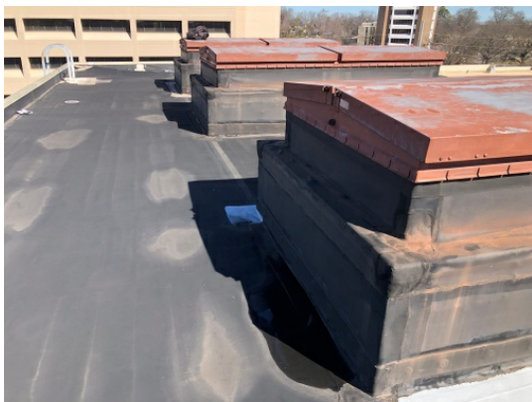
Photo 5

The brown areas are from ponding water which is showing how the insulation has come loose and there are substantial high and low areas on the roof.

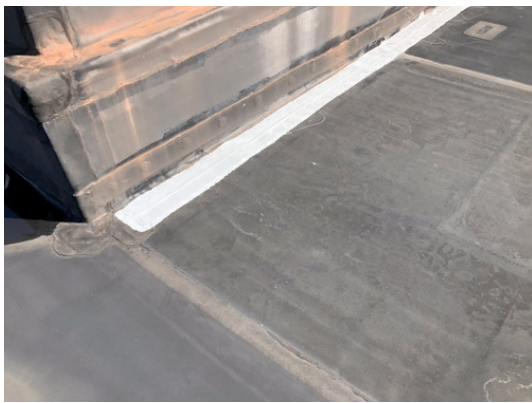
Photo 6

The white strip is from a previous repair at the base of this roof curb.

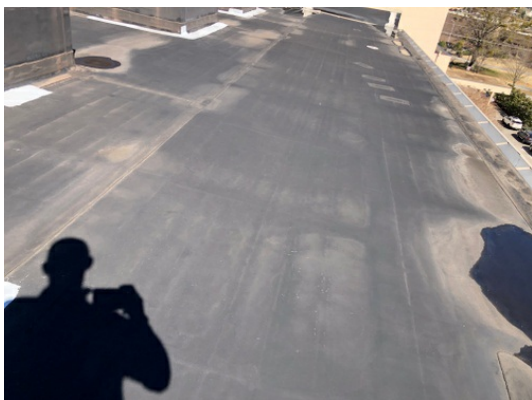
Photo 7

Water ponds in front of the gutter

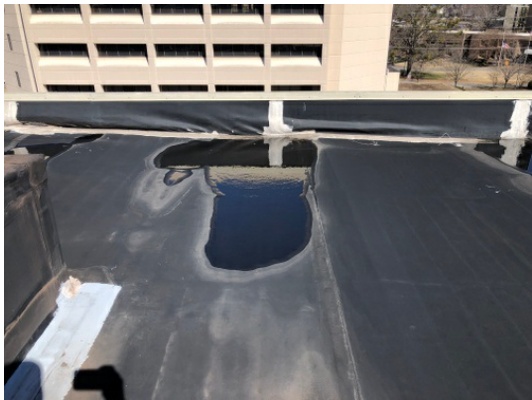
Photo 10

The insulation is loose and has buckled up which is holding this water back from draining.

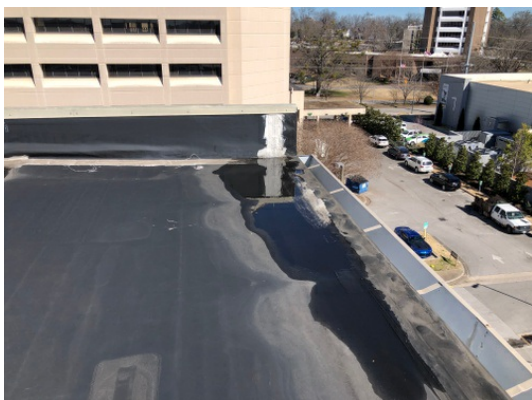
Photo 11

Water is ponding in front of the gutter.
